PERFORMANCE EVALUATION OF IOWA BRIDGE DECKS CONSTRUCTED WITH EPOXY-COATED REINFORCING BARS

Final Report

August 19, 2011

Iowa Department of Transportation

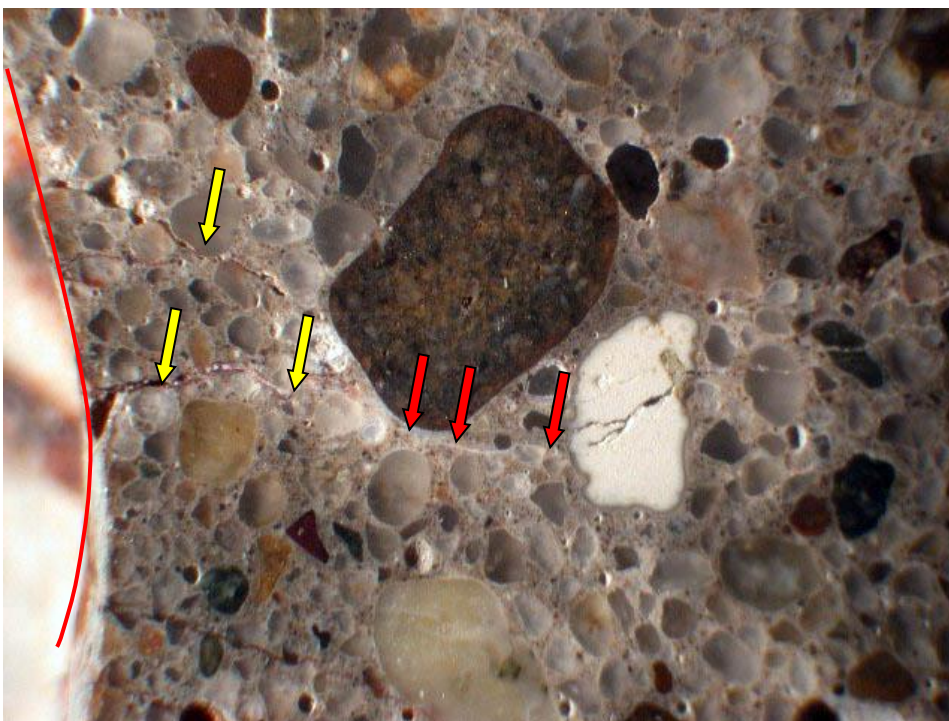
Figure 44. A cross-sectional view oriented perpendicular to the axis of an impression of an embedded steel reinforcing bar contained in Core IA 150 #5. The red curve marks the intersected surface of the steel reinforcing bar impression. Several cracks that were judged to have initially been induced by deposition of corrosion by-products from the embedded steel reinforcement are marked with yellow arrows. Iron oxide deposits are visible along these cracks. The red arrows mark the extension of the one of the corrosion-induced cracks. Silica gel has been deposited along the portion of the same crack in the region marked with red arrows. The width of the field of view is 0.5 inch.
